The Locomotive

OF
THE HARTFORD STEAM BOILER
INSPECTION AND INSURANCE CO.

INDEX
to
VOL. 42 - 43

HARTFORD, CONN.
1938-1939

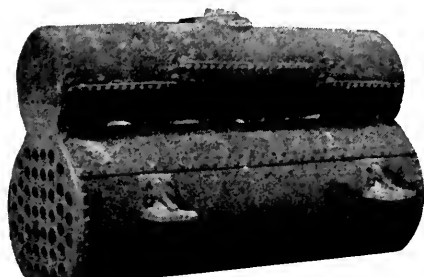
the head at the knuckle just above the seam, and both head and tank crashed into 6" steel I-beams supporting the floor above. One of the beams was bent and two others dislodged from the brickwork. Wiring, piping and windows were also damaged.

While the head plate was somewhat corroded on its internal surface, the greater part of the thinning, from a normal thickness of $\frac{3}{8}$ " to an average of $\frac{1}{8}$ ", was on the outside. As the head of the tank was only 9" below the charging floor, it had been frequently subjected to moisture when the floor was washed. The photograph shows the defective part of the head, and the seam, which was cut away from the shell following the accident. The tear started at a point just to the left of the lap seam. The rip at the right occurred when the head hit a steel beam.

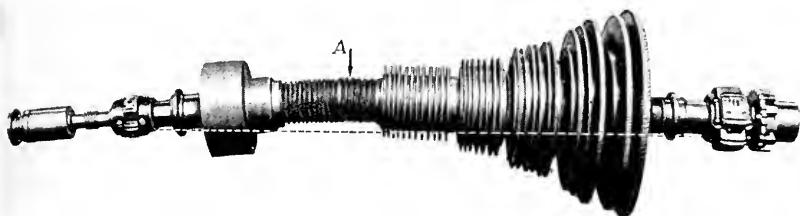
Figure 1—The photograph was purposely distorted to make clear how the shaft was bent and just where heat was applied. The distortion of the shaft is, of course, absurdly exaggerated.

was then applied at "A" (Figure 1) on the top of the spindle (the high side) by means of two oxy-acetylene torches. An asbestos ring was placed around the point that was to be heated, so that a quick heat could be obtained at that location. As soon as the heat was applied at the top, that side of the spindle began to expand and to rise, so that the bow in the spindle was even greater than before the heat was applied. This was seen on the dial indicator, which immediately began to show a plus reading. For the various heats, the torches were applied for periods ranging from 20 to 90 seconds which caused the indicator to show a maximum plus reading of 70 mils for the longest heat, but the best results were obtained by using a heat that raised the spindle only about 30 mils at each heating. As soon as the torches were removed and the top of the spindle began to contract, the drop of the spindle was rapid at first and then more gradual until the indicator again read zero within ten minutes' time. With further cooling of the spindle, the indicator began to show a minus reading until from minus 4 to minus 12 mils for each application was secured after 30 minutes of cooling. This

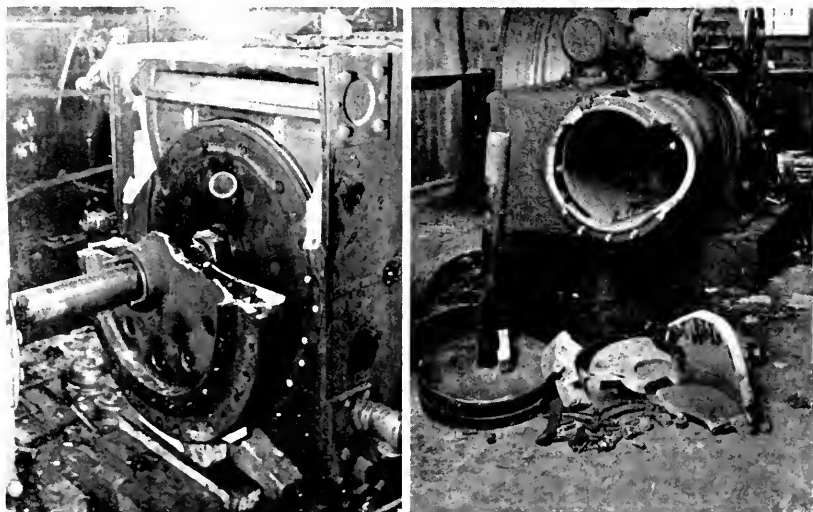
Figure 2—(Left) the result of a connecting rod crack. Figure 3—(Right) the result of a failure in the threads on the piston rod just inside the crosshead.

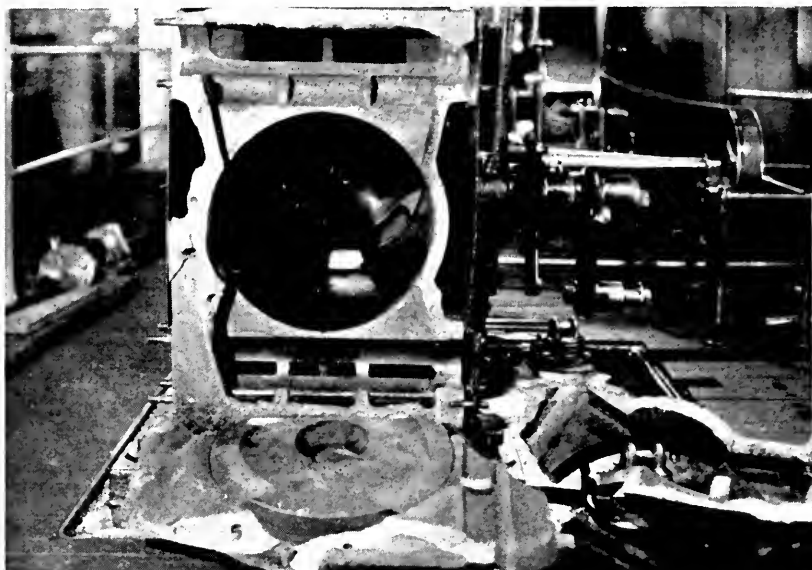
Figure 4—An accident attributed to the failure of follower bolts.

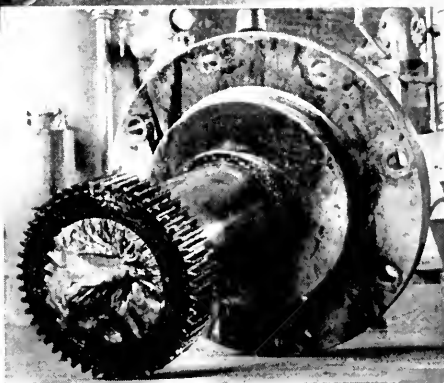
Engine Crankshaft Failure

THE breakage of this crankshaft in a 140 hp Diesel engine used at a New England ice plant was attributed chiefly to torsional vibration. Starting around the circumference of the shaft under a fillet at a web, cracks progressed into the shaft and so weakened it that it broke after about one year's service.

The failure, which was roughly conical in shape, is typical of torsional vibration breaks with their radial failure lines. In this installation the timing gear was immediately adjacent to the break. Beyond it (to the left in the top picture) was a main bearing and outside this a 5,700 lb flywheel. It is felt that the weight of the wheel added to the stress at the point of failure and hastened the break. The direct damage loss, which amounted to nearly \$4,000, was covered by Hartford Steam Boiler.

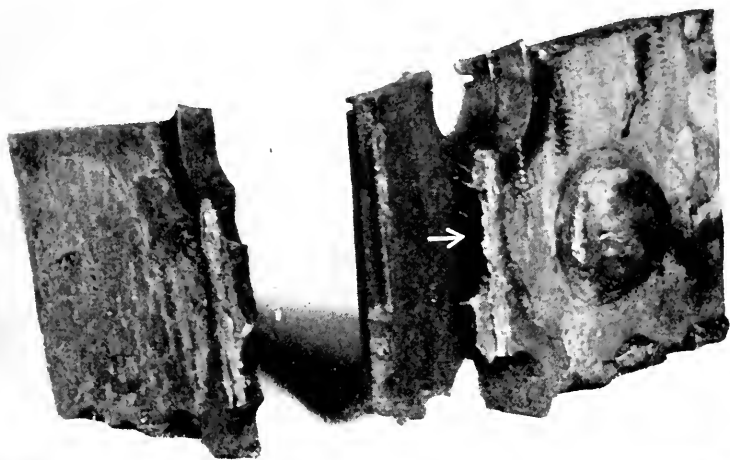
The line of rupture was found to have followed a series of defects which started at the walls of the rivet holes near the interface, or hidden surface of the shellplate forming the inside lap of the seam. It should be understood that the hidden surface becomes the outside surface beyond the line of caulking.

In a general way, development of those defects was in the zone of greatest stress and was toward the adjacent rivet holes. As the defects progressed, they penetrated the sheet to a greater distance from the interface. The result of this combination of developments was a number of areas where the grains of the steel were in intimate contact, but without the strength afforded by the grain binder. A similar defect is shown in Figure 2 in which the dark areas are those in which grain binder corrosion has developed and the bright areas show the break

Figure 2—A fully developed embrittlement defect in metal from one of the steamer's boilers. The lower picture shows the rivet hole to rivet hole direction of the disintegration. The top picture is of the same pieces of metal as the lower, the dark areas in the break illustrating the development of the embrittlement (see arrows).

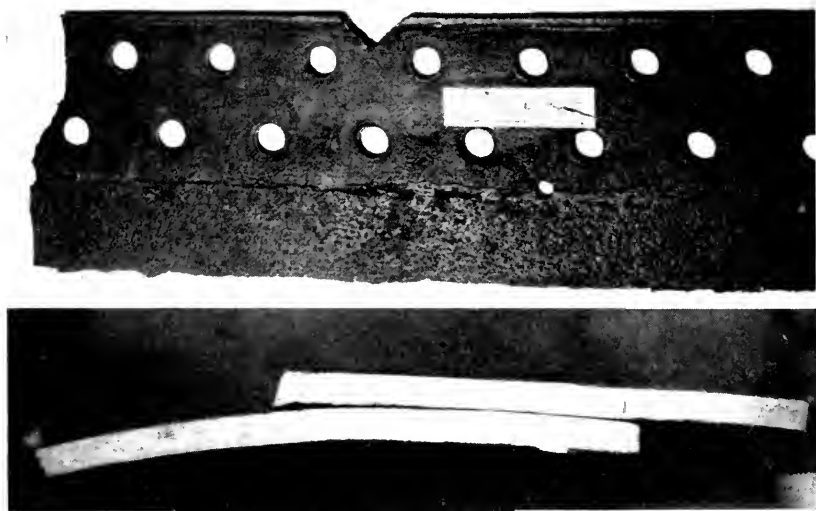
Figure 5—Top and end views of a typical lap seam crack. Notice that this defect is on the opposite side of the seam from the failures shown in Figures 1, 3, and 4. The picture at the upper right shows a lap seam failure under hydrostatic test.

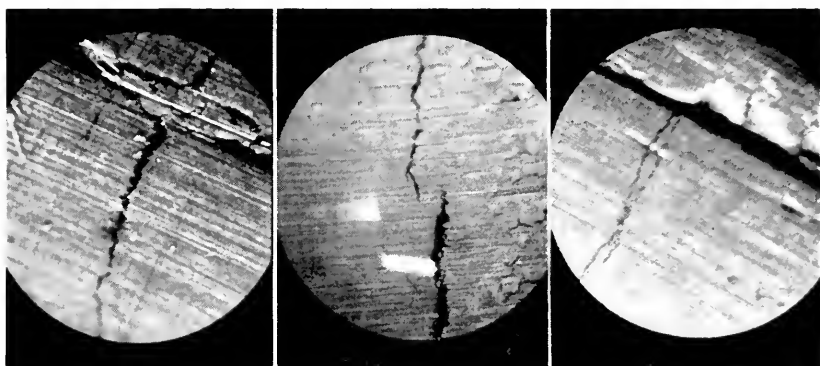
Figure 6—Embrittlement defects from Boilers Nos. 1, 2 and 3 (from left to right) as seen in rivet holes through the Hartford Steam Boiler magniscopes.

Many of the defects were then visible to the naked eye. Photographs of these defects at 40 magnifications in boilers Nos. 1, 2 and 3 are shown in Figure 6. In Figure 7 is shown a defect of the same sort at 225 magnifications as photographed at the University of Illinois laboratories during recent embrittlement research. In Figure 8 is a photograph at 500 magnifications of an embrittlement defect from the No. 1 boiler.

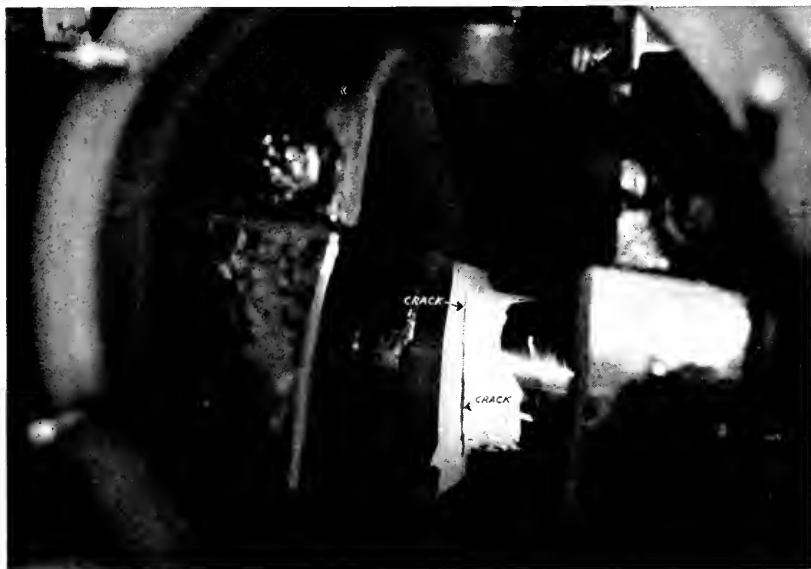
Figure 1—Crack in the fillet of the crankweb and crankpin of a Diesel engine. It was located by means of the whitewash test without dismantling the engine.

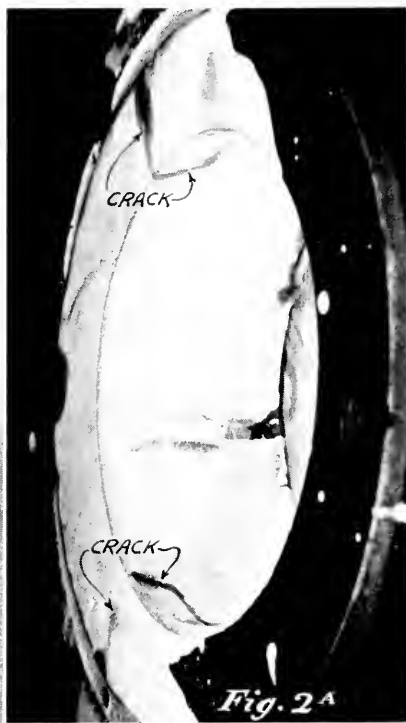
Figures 2 and 2A—Whitewash test showing crack across one of the eyes on the inside of a crosshead.

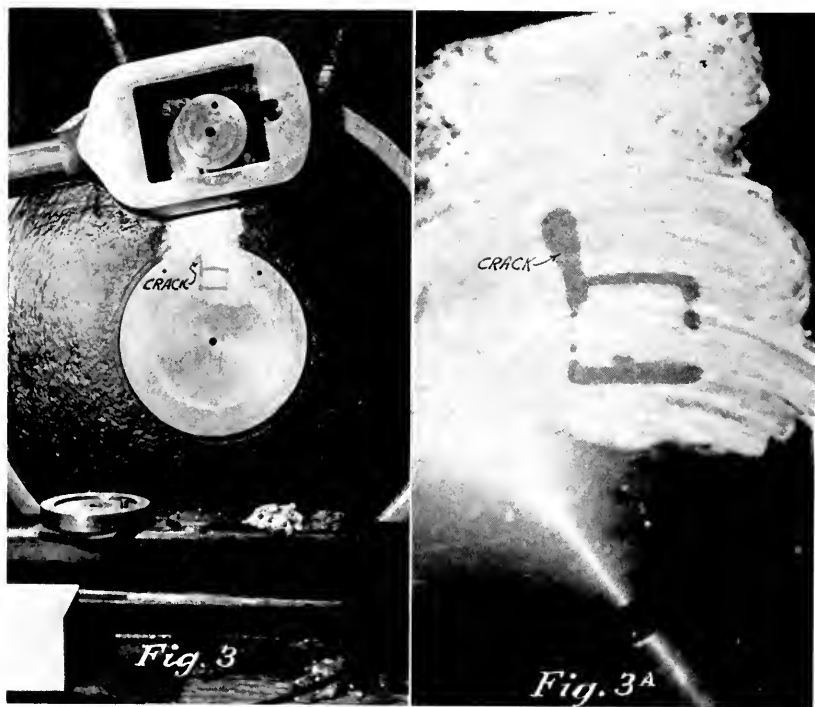
Figure 2 shows a crack across one of the eyes on the inside of a steam engine crosshead. Figure 2A is a magnification of the same defect. Figure 3, and the accompanying magnification in Figure 3A, show—at the corner of the keyway in a steam engine crank—a crack which

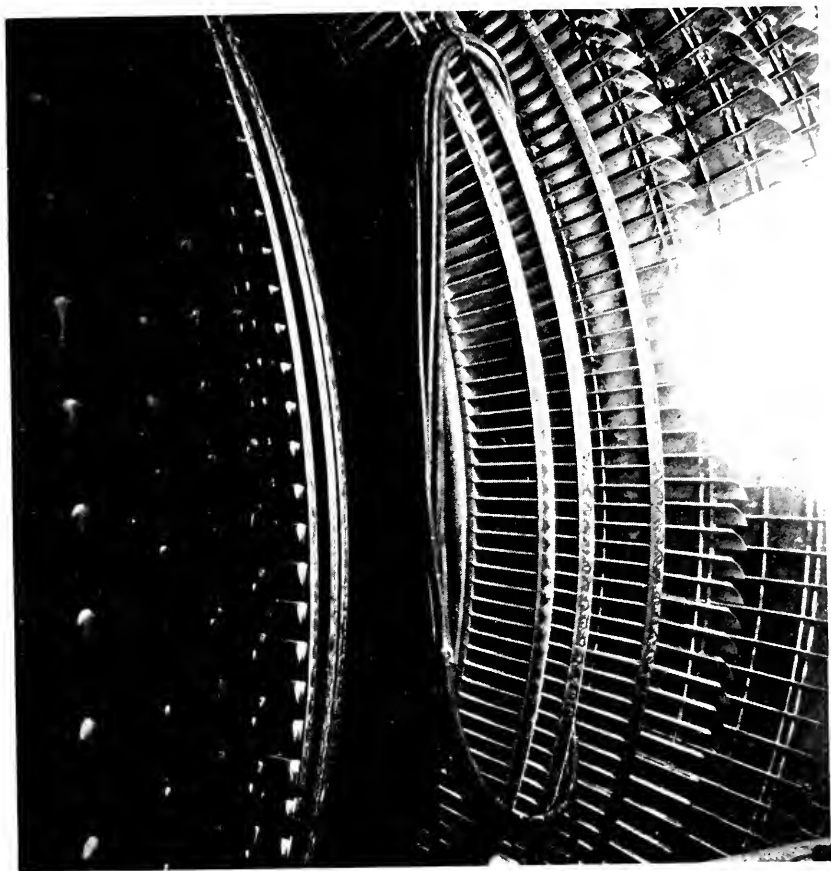
Figure 4—Applying the Magnaflux method of crack detection to steam turbine blading.

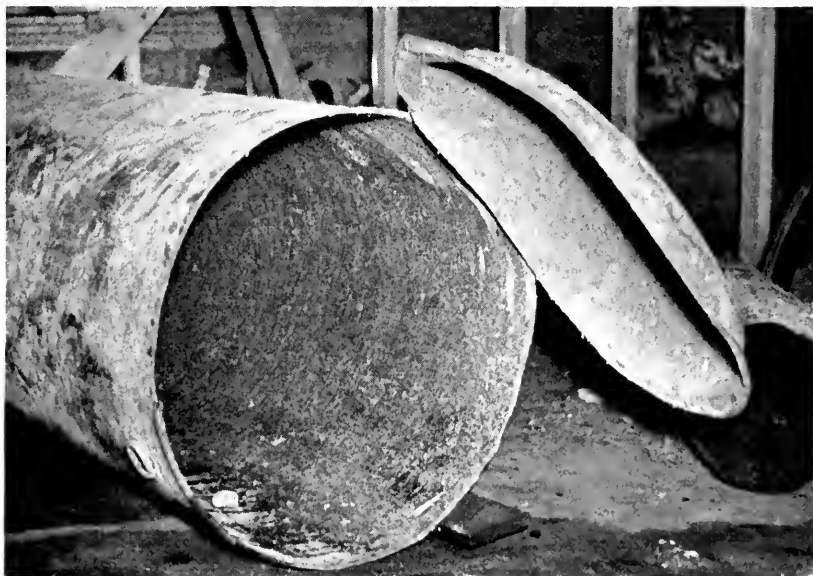
Figure 2—The tank which failed. The reversed minus head is clearly shown.

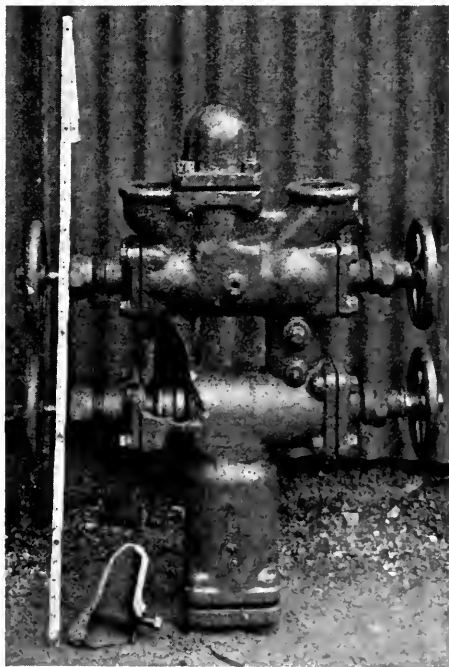
Figure 1—Ammonia compressor manifold which exploded because of an excess of pressure within it. The failure led to the death of an engineer, who was drenched with the refrigerant.

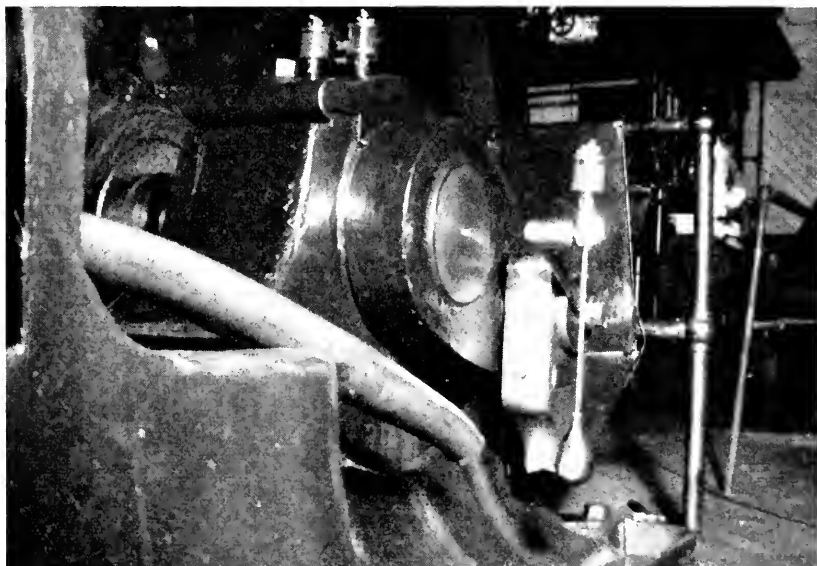
Figure 6—Broken connecting rod of a 150 lb ammonia compressor. The accident was attributed to an attempt to start the compressor 3 times in spite of burned out fuses. The discharge valve had not been opened.

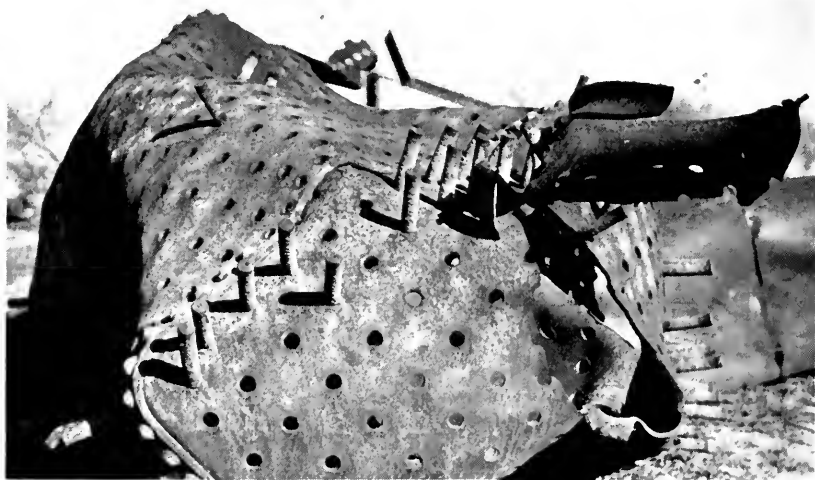
Figure 1—Firebox of a locomotive type boiler in an oil field after its explosion due to low water and over-heating.

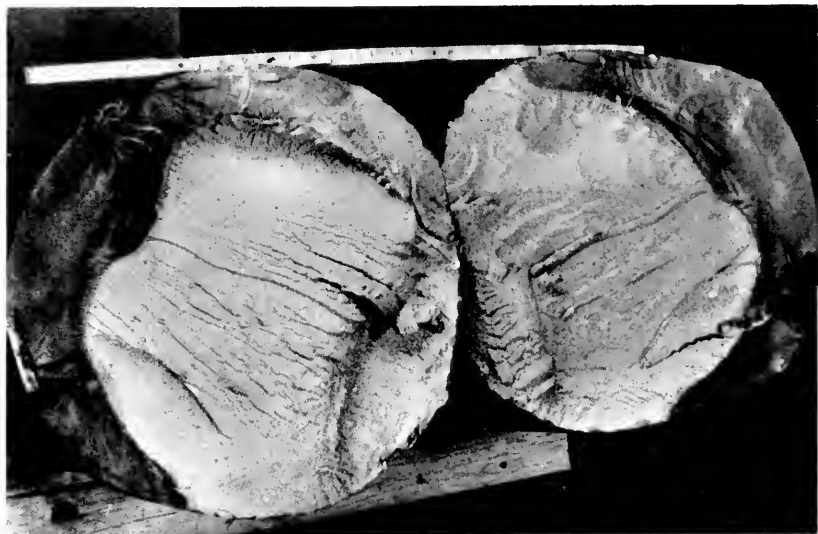
"He had been told that the 18" shaft on this particular engine had been built up by applying weld metal some two years ago when a new flywheel was installed, so he knew that in addition to the regular inspection procedure, he should pay particular attention to this part of the shaft.

"You see, Mary, when a shaft is made larger by means of depositing weld metal on it, the welding arc results in an intense localized heat on the surface of the shaft, which results in excessive stresses in the metal and it may even cause a tiny crack to form."

"The darker metal shows how far the crack has progressed."

"So the machine was dismantled and the shaft broken by impact. The darker metal shows how far the crack had progressed when Benson found it. In the other picture the two ends are held together to show the crack with respect to the location of the built-up section of the shaft."

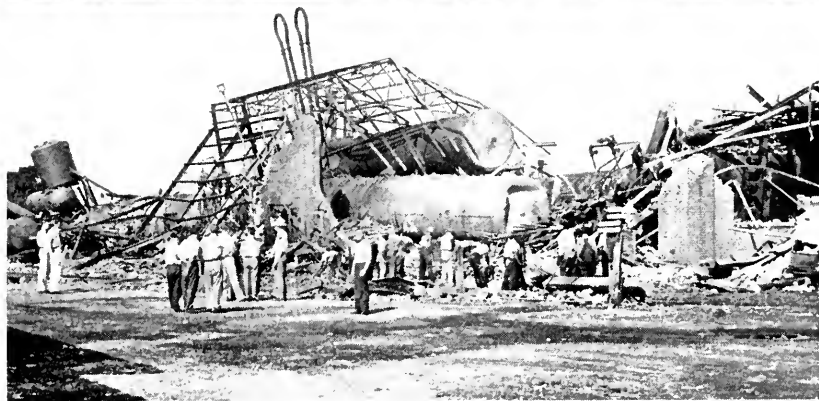
Figure 1—Top page 226—Damage after the explosions of a creosote tank and a water tube boiler at a southern plant.

Although the exact cause was not determined, presumably the explosion in the 9' x 80' Reuping tank was a combustion detonation. One end of the tank blew away and the rest slid into the boiler room, striking or knocking debris against a water tube boiler operating at 150 lb pressure. The blow caused a girth seam to fail and brought about the second explosion. Most of the boiler was hurled about 100 feet.

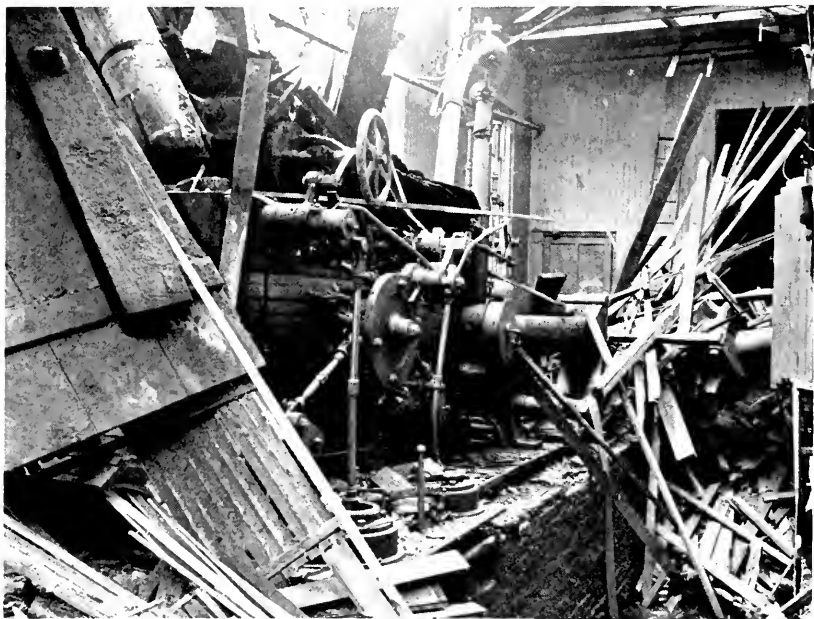
A FLYWHEEL explosion at an eastern manufacturing plant caused the havoc presented in the accompanying photograph. Parts of the wheel went through the roof of the engine room, causing it to fall, and also crashed through an adjacent roof into a room where about 100 women were working. In the ensuing confusion, according to a newspaper account, two of the women were injured when

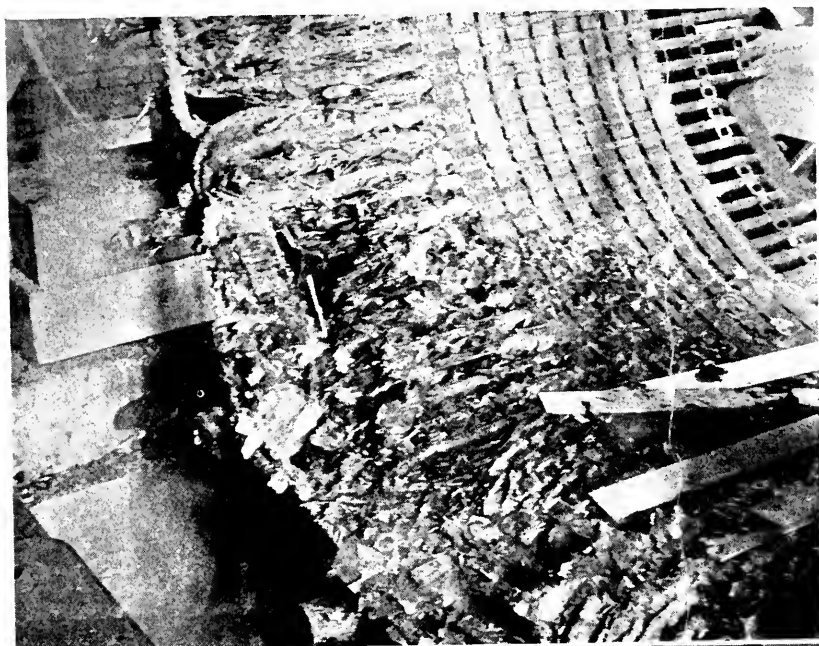
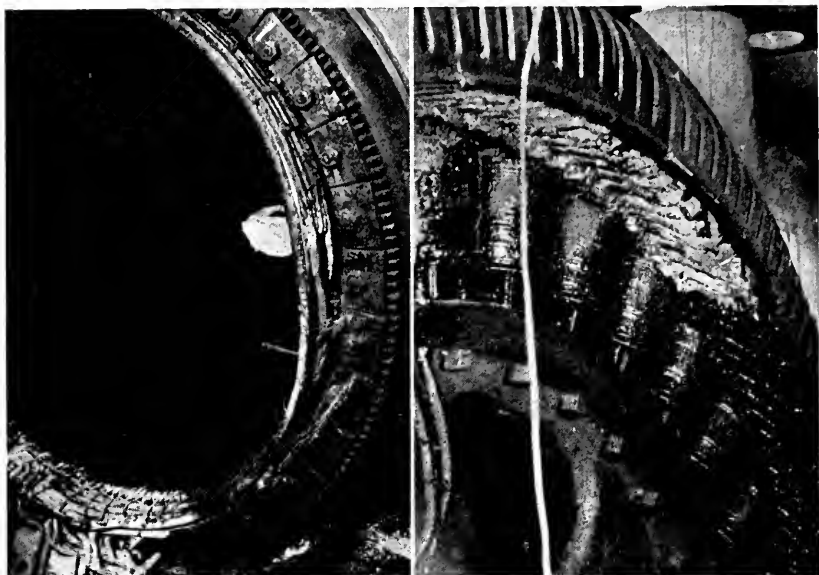
Generator Accidents

Top, Page 2—Stator burnout on starting. The machine is a 2500 kva AC generator, part of a frequency-changer set, at a county utility. Bottom, Page 2—Two failures of turbo-generators because of lightning. The picture at the left shows a 3,000 kw machine at an oil refinery and that at the right a 750 kw generator at a municipal utility. Above—Left—A high frequency 1125 kw motor-driven alternator used at a boiler factory. Half of the coils were damaged when insulation failed on end turns. Right—Short circuiting of turns in one coil brought damage to about 60 other coils of a 168 kw generator driven by a steam engine at a manufacturing plant.

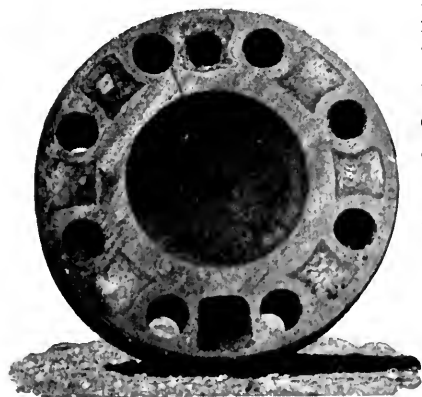
Figure 1—Diesel cylinder-head completely choked with scale. The faulty water condition in connection with an open cooling system caused repeated failure of the cylinder-heads on this engine.

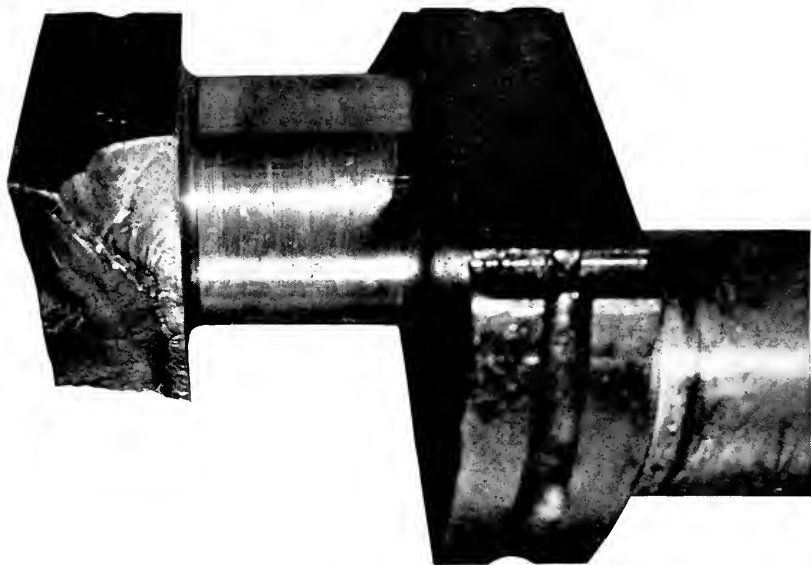
Figure 2—Crank distortion caused by bearing misalignment resulted in the breaking of this crankshaft. The fatigue cracks started in the fillet on the journal side of the crankweb.

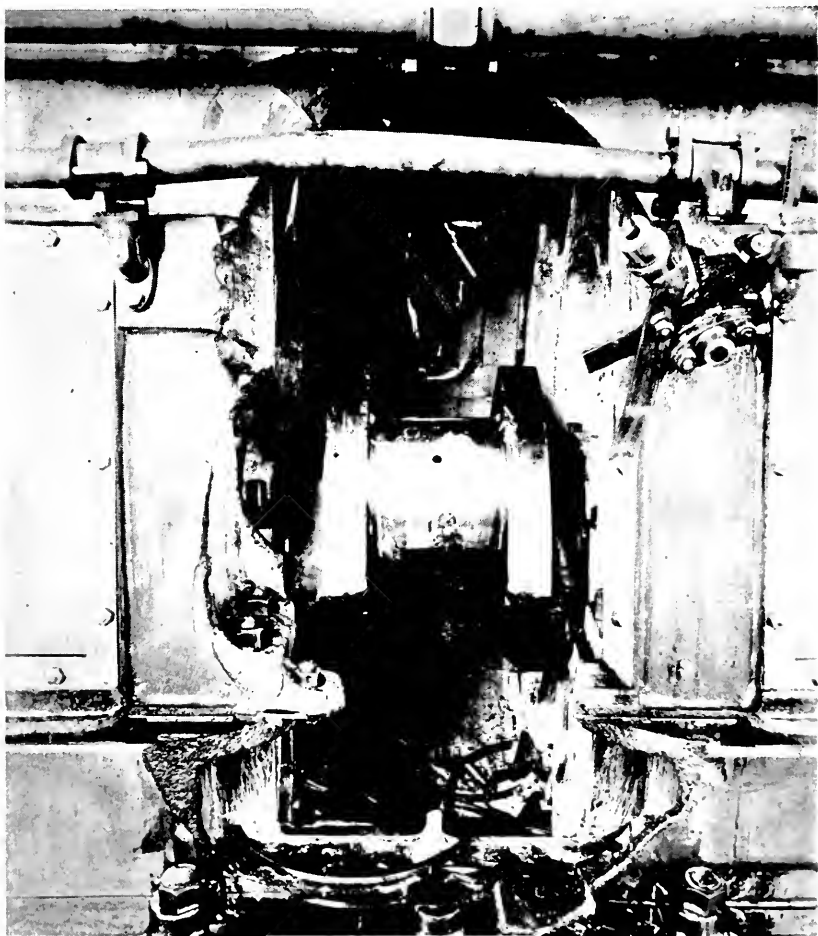
Figure 3—A wreck brought about by a crankbolt failure in a 2,000 hp engine. This accident resulted in a lost estimated at \$15,000. Vertically the picture shows about 5 feet of the engine.

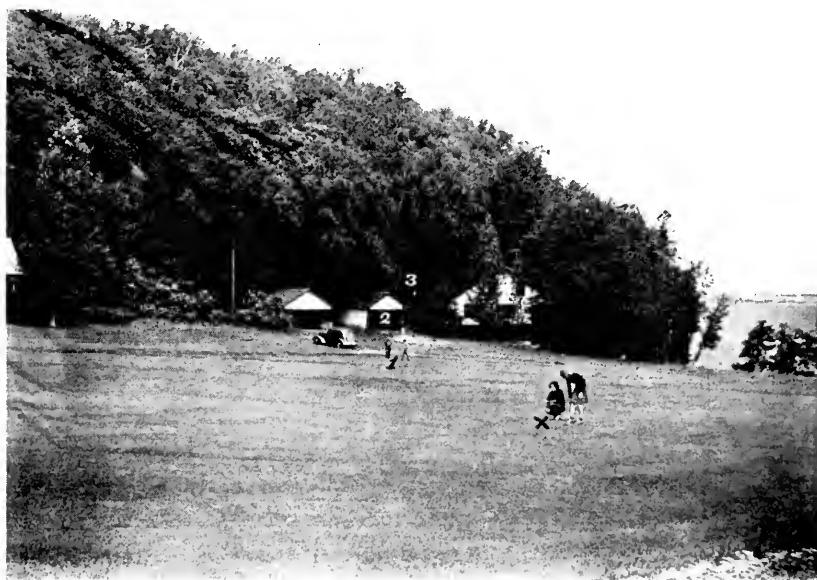
Hot Water Tank Blast Kills Three

This pleasant spot on the shore of Lake Champlain witnessed the deaths of two men and a young girl one evening last summer. A hot water tank exploded in a small building at the location marked "3," struck the two men who were about 15 feet away, caromed into the garage "2," struck the girl at "1" and finally came to rest at "X" after traveling 750 feet. The accident illustrates the tremendous force inherent in hot water under pressure and above the atmospheric boiling point. In some way the building housing the tank had caught fire. The heat from this was believed to have brought about the explosion as it rapidly raised the pressure in the tank to a point which it could not withstand.

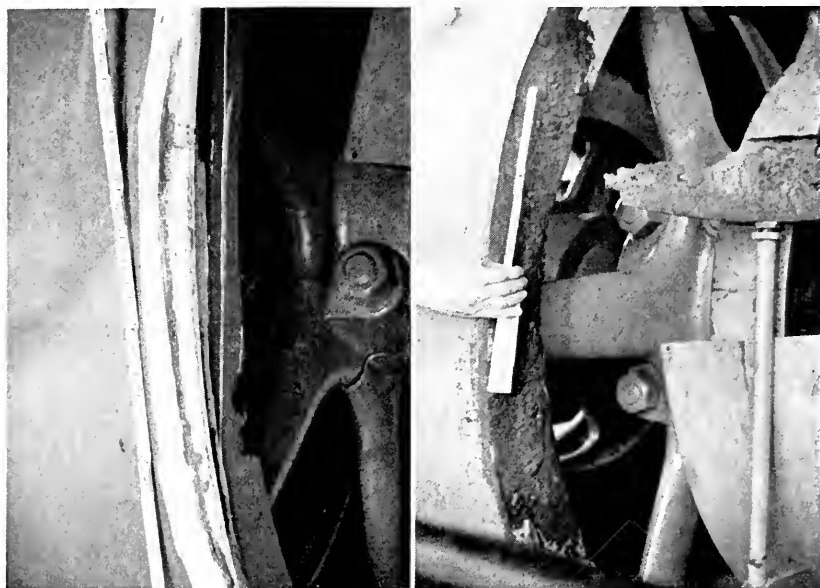
Unusual Flywheel Defect

The illustrations show a casting defect in a 40-year-old flywheel. The engine on which this wheel was used had not been in operation for two years as it was kept as a stand-by for emergency service. It was given a test run each week.

The presence of the circumferential crack was suspected, and a whitewash test applied with the results shown in the photographs. By means of a few well-directed hammer blows large slabs of cast iron came off the wheel rim. Apparently, the defect was attributable to faulty casting practice at the time the wheel was poured.

It was fortunate that the heavy slab of metal never became detached sufficiently to be thrown off by centrifugal force when the engine was in operation.

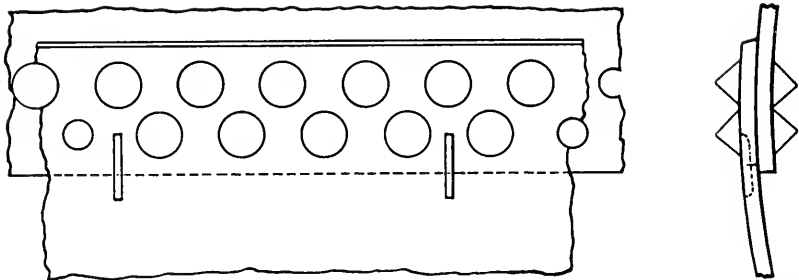
AN explosion of a large air tank was undoubtedly prevented when longitudinal cracks were discovered recently by cutting slots in one of the seams. As this tank was of lap riveted construction the inspector suspected a crack when he found leakage, although slight, along the caulking edge of a seam that showed signs of repeated caulking. On his recommendation, the seam was slotted at several points and leakage through these slots with the vessel under hydrostatic pressure showed definitely that a crack had developed in the plate forming the outside lap of the seam. As is usual with this type of crack, it started from the hidden side of the plate and could not be seen. The slots, made at right angles to the direction of the probable cracks, are shown in the accompanying photograph of the tank.

Possible explosion of this air tank was averted when hidden cracks were found by slotting the seams.

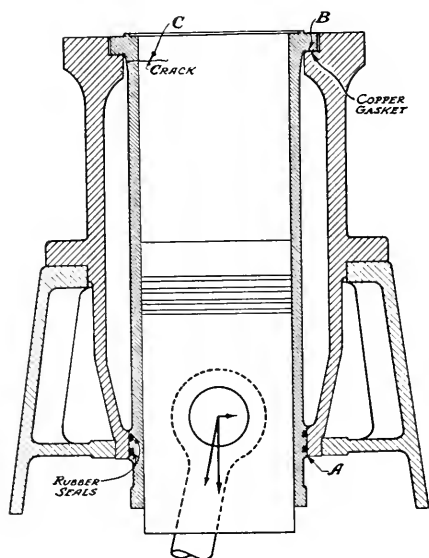
Figure 1—Typical design of removable cylinder liner showing the usual method of liner support in the cylinder block.

Still another source of bending strain at the neck of the liner flange is an appreciable unevenness of the contact surface at "B." Originally this is a carefully ground surface and the liner is fitted by using Prussian blue and scraping to a complete contact with the supporting flange in the cylinder block. A copper gasket of about $1/32$ " thickness is then used to insure tightness. However, after a cylinder liner has been in use for many years the cylinder block may become warped to such an extent that there will not be an even contact over the entire surface of the flange.

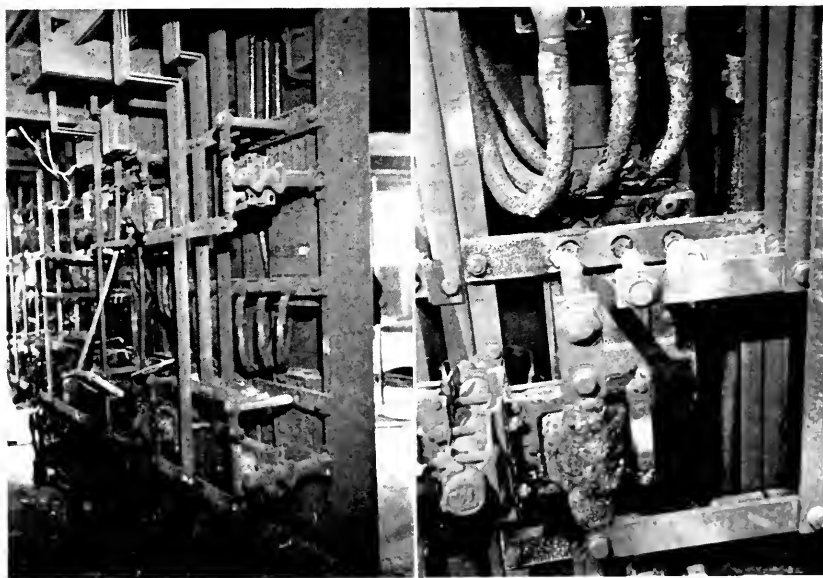
Figure 2 and 2A—Views showing a circumferential crack near the top of a 15" cylinder liner. This crack permitted leakage of water into the cylinder.

In a number of cases that have been investigated recently, cracks had progressed until water began to leak through from the jackets into the cylinder. Further investigation revealed that there was considerable clearance between the cylinder blocks and the liners (point "A") in several of the other cylinders in these same engines. In one case, after a liner had cracked a distance of 12" circumferentially—See Figures 2 and 2A—a clearance of 23 mils was found between the block and liner of another cylinder. On pulling this liner two cracks 5" to 6" long were discovered, although neither crack extended through the liner.

Cracks that arise from bending or flexing of the liner will, as a rule, start on the outside and cannot be found unless the liner is removed from the cylinder block. When a failure has occurred to one liner in a multiple-cylinder engine, the others in that same engine are very likely to have similar cracks. It is particularly advisable that in such cases all the cylinder liners in the engine be removed for inspection. By this procedure other forced shutdowns can be prevented.

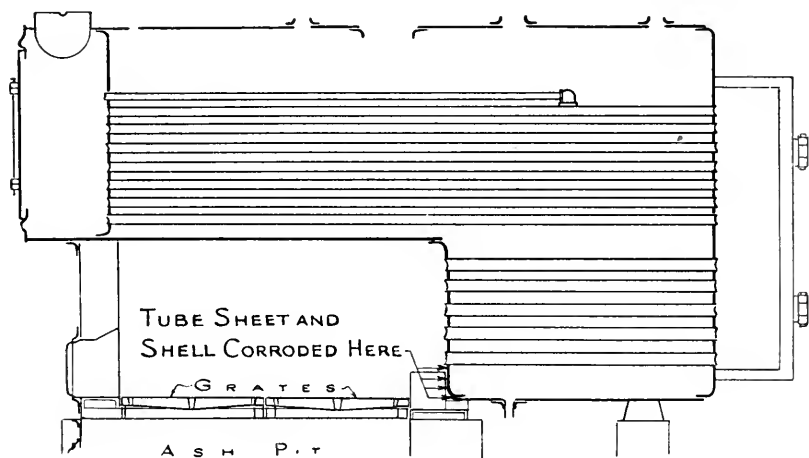
Figure 3—Drawing of an economic-type boiler indicating areas concealed by grates or brickwork where external corrosion is likely to occur.

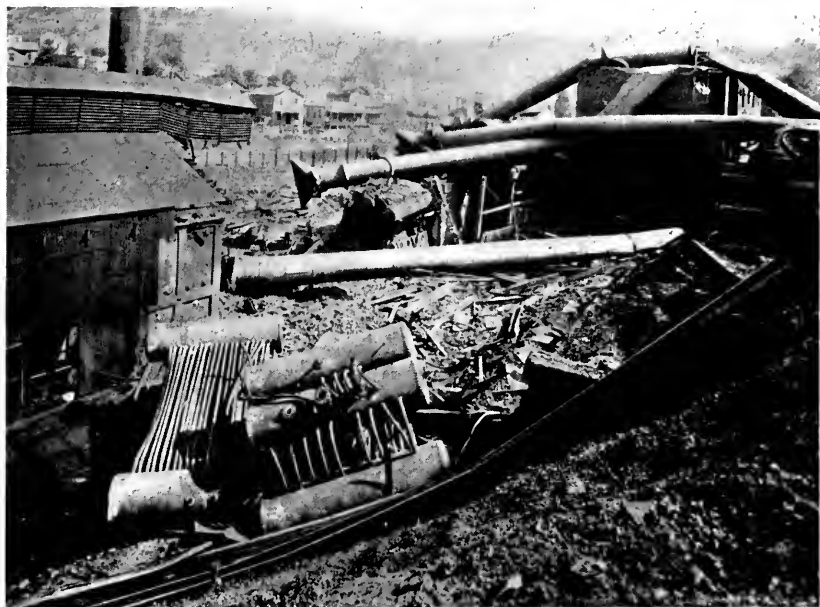
Figure 4—Wreckage at a steel mill following an explosion of a water tube boiler. Caused by external corrosion of one head of the lower drum which had been concealed in brickwork, the explosion killed two people and injured five others. Property loss was about \$75,000.

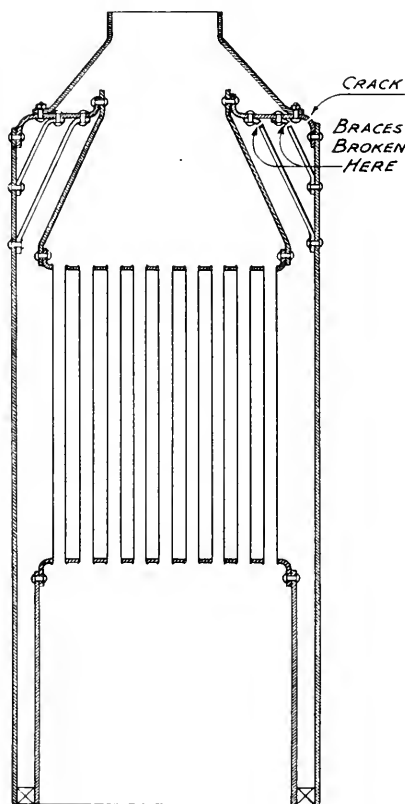
Figure 5—Three men were badly scalded when the top head of a small vertical tubular boiler, similar to the one drawn here, tore open at the flange along the line of a previous crack.

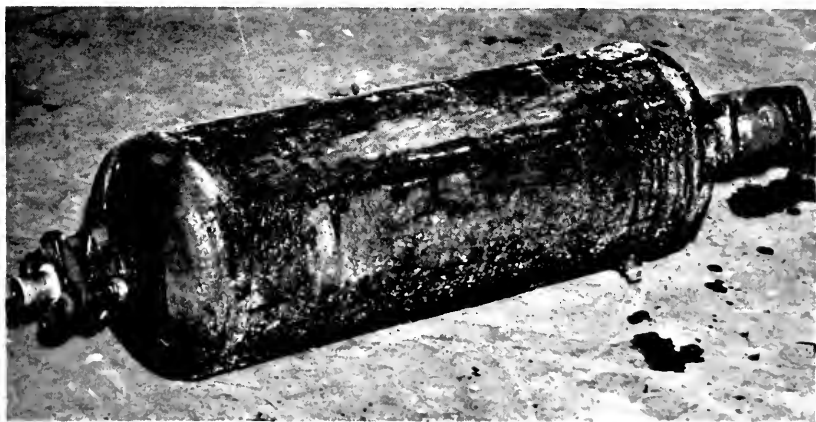
Figure 1—Five men were injured (three of them fatally) by the rupture of this ammonia receiver along a welded seam. Overpressure from expansion of the ammonia when an acetylene torch was used to cut a connected pipe was the probable cause of the failure.

to have been pumped out of the receiver before the work was started. One of the men was cutting a connected pipe line with an acetylene torch while the others were unbolting the receiver supports when the vessel suddenly burst along a welded longitudinal seam as shown in Figure 1.

In attempting to determine the cause of the accident, it was found that all pipe lines connected to the tank were equipped with stop valves which had been closed. As there was no safety valve on the receiver and as the ammonia probably had not been pumped from it, heat from the acetylene torch vaporized the liquid ammonia and increased the pressure in the vessel to an amount greater than it could withstand.

A vessel that can be entirely isolated from other parts of the system by stop valves should be equipped with a relief valve, and care should be taken in changing or repairing refrigerating systems to make sure that the vessels or pipes on which the work is to be done do not contain refrigerant.

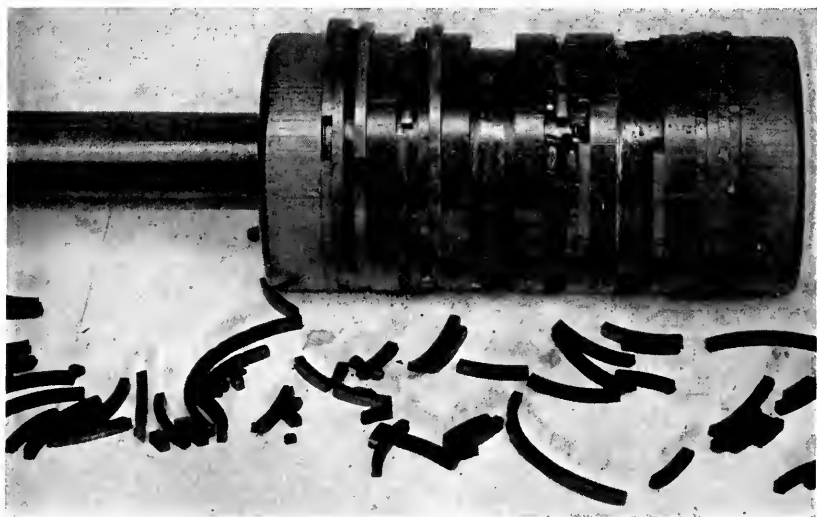
Figure 5—Carbon-dioxide compressor piston and rings damaged by a piece of valve spring which worked its way between the piston and cylinder wall.

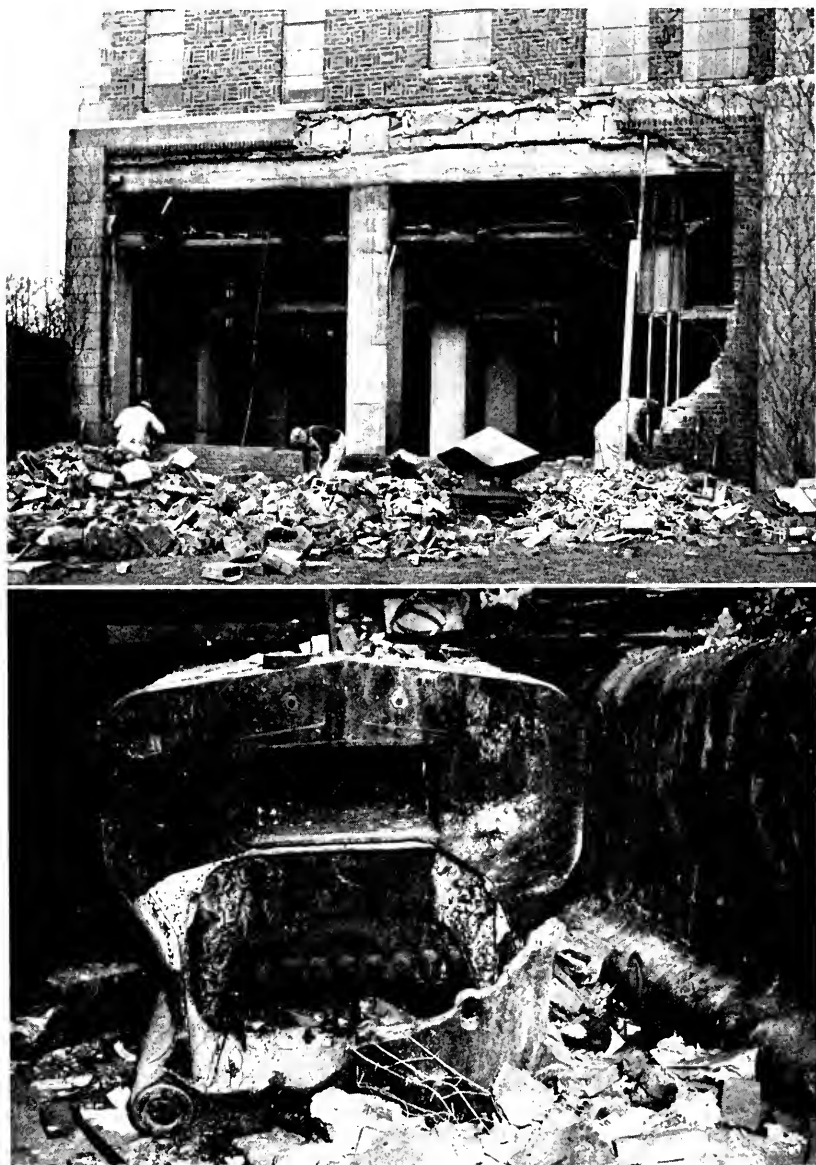
Figure 1—Top—Section of a brick wall in a large apartment house demolished by an explosion in a cast iron steam heating boiler.

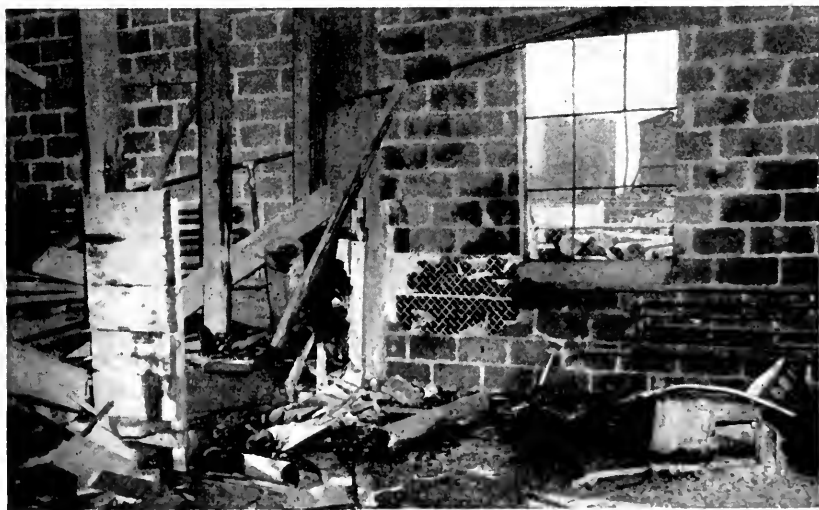
Figure 3—After an explosion of a cast iron hot water heating boiler in a garage. Originally located adjacent to the hole in the rear wall, the base of the boiler was hurled several feet to the right.

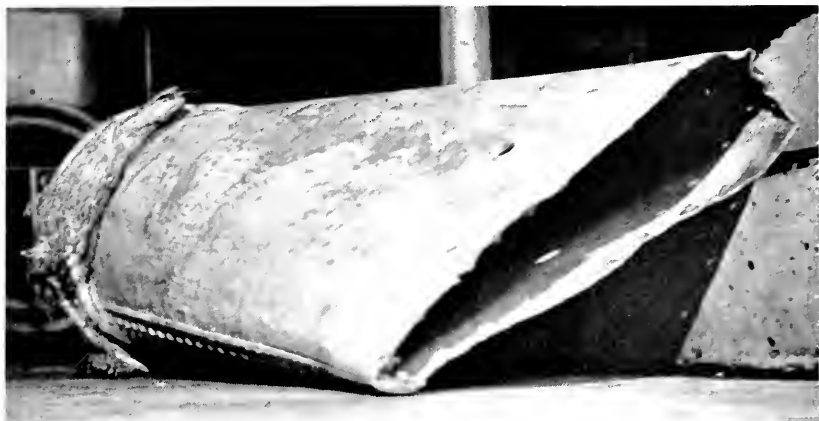
Figure 1—Over-pressure caused explosion of this hot water tank in a laundry. The property loss was over \$5,800.

Figure 1 shows a picture of a new hot water tank after it had exploded from over-pressure. This failure occurred in a cleaning plant and resulted in damage amounting to more than \$5,800.

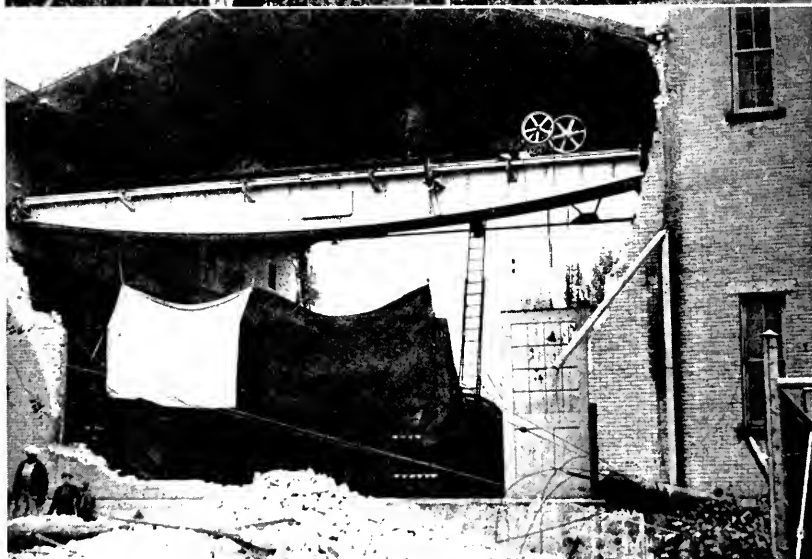
Two views of a utility sub-station after an explosion, caused by a direct stroke of lightning, blew out the end-walls.

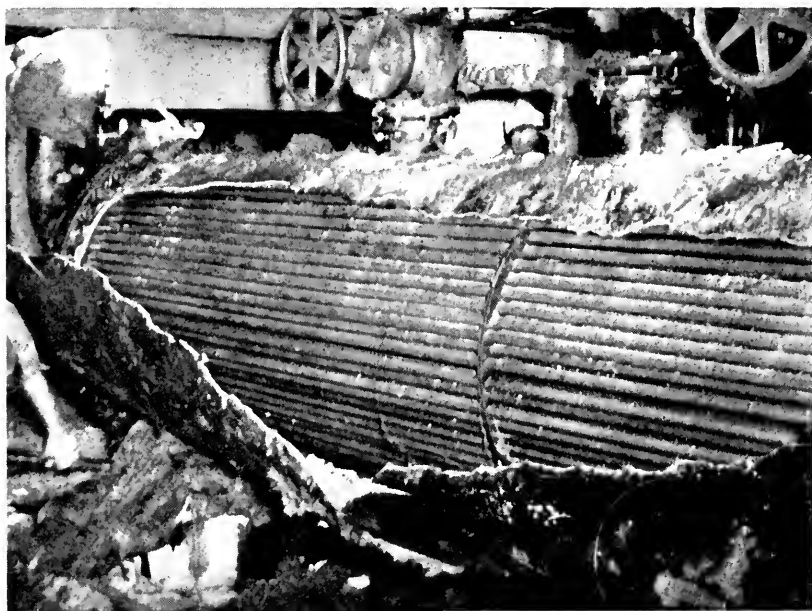
Scale resulted in overheating and bulging of a number of water-wall tubes in this boiler. Change in the feedwater supply without proper adjustment of the feedwater treatment caused the scale accumulation. Two of the damaged tubes are marked. Cost of repairs was not large but several hours of production were lost before steam could be supplied by spare boilers.

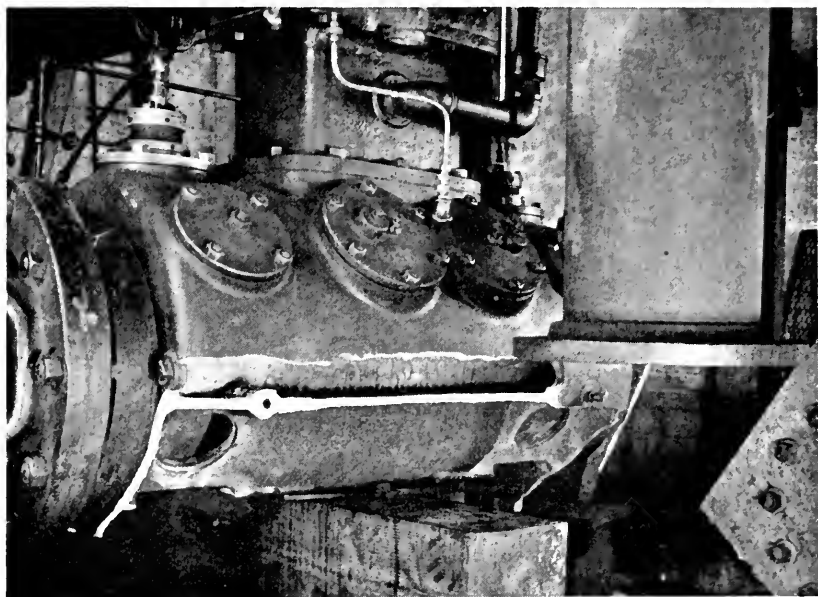
Figure 1—High pressure cylinder on a two-stage motor-driven air compressor damaged by an explosion. Excessive air pressure or a combustion explosion may have been the cause. The operating engineer was killed.

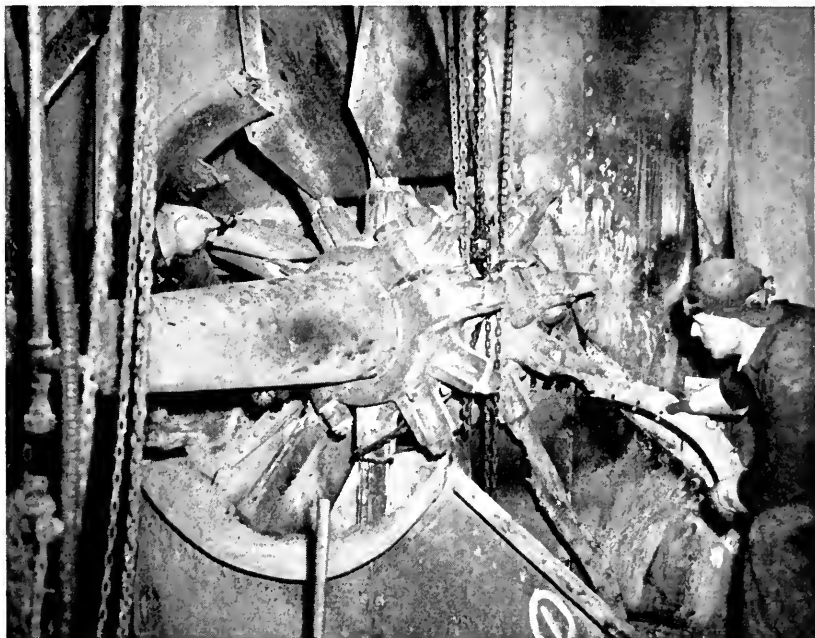
Figure 1—Part of the damage to one-half of a duplex-type induced draft fan, 450 hp capacity. Erosion of the shrouding and excessive temperature of the stack gases caused the accident.

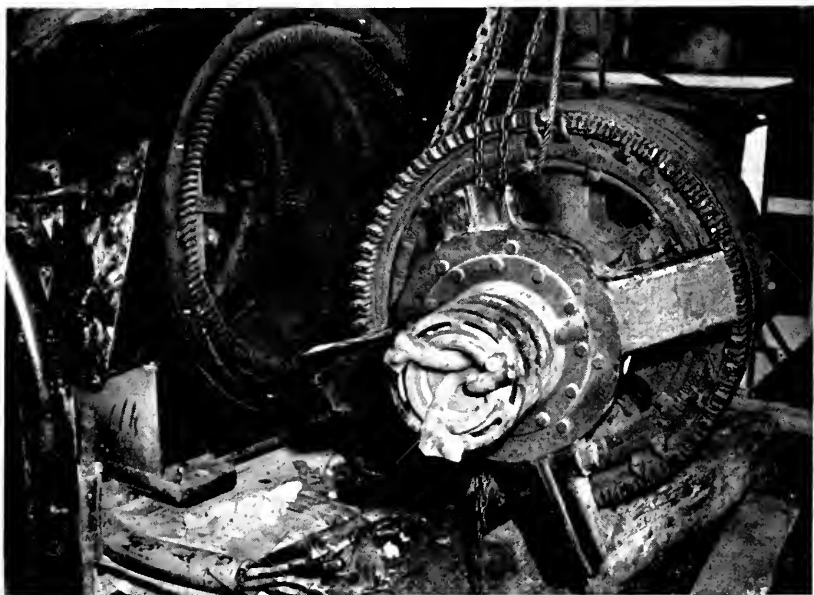
Figure 2—Connected through a coupling to the draft fan shown in Figure 1, this 450 hp wound-rotor induction motor was wrecked by the severe vibration which resulted from the disruption of the fan.
